# Manhole Inspection Summary

Manhole # S45MM\_017MH

Insp Date: **3/25/08 9:54 AM**

**Location** Address: **20th**

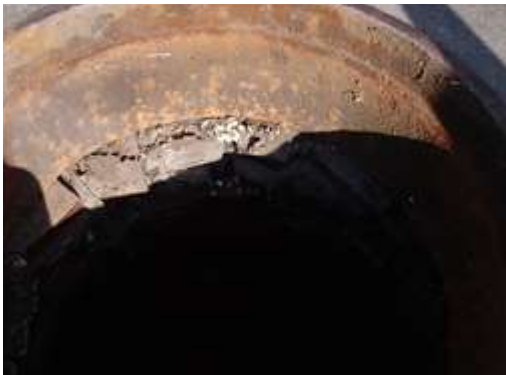
Defect 2

Offset: **4** (in.)

Frame offset

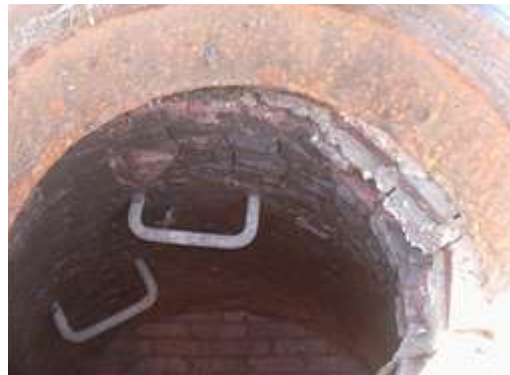
Defect 1

Condition: ☐ Sound ☐ Cracked ☐ Root Intrusion ☒ **Loose Brick** ☐ Deteriorated

Loose bricks

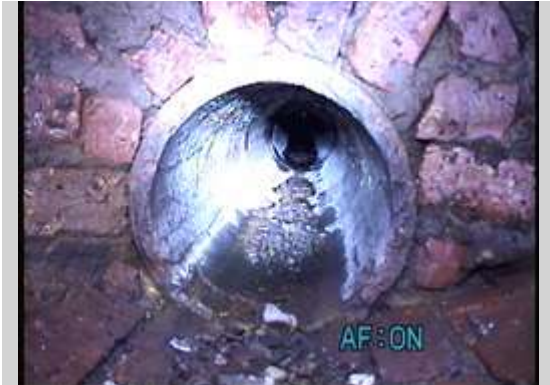
12 O'Clock Outflow

8 in. Circular Gravity Sewer  
Pipe Out @ 12 O'Clock

Deposits: ☐ None ☒ **Mud** ☐ Sludge ☒ **Debris** ☐ Grease

Silt Depth: **1** (in.) Deposits Extent: **Light**
